The State of the Shaft

A discussion about a sometimes-overlooked component of elevator maintenance

by Kaija Wilkinson

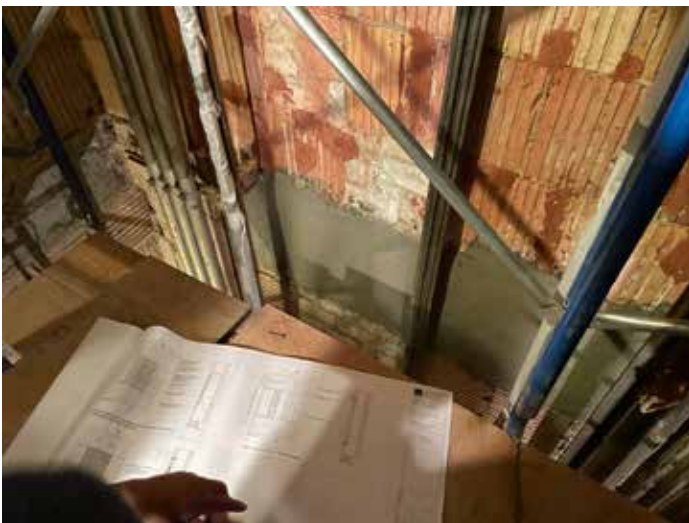
Surveying the shaft

DG: Elevator shaft surveys should be mandatory once every three to four years, as shaft conditions can change due to water penetration, vibration, nearby construction projects and other environmental conditions. Elevator machine room walls and ceilings have encountered similar issues, which can cause debris to fall onto and into equipment. These spaces should also be inspected. Performing such surveys is a proactive approach that can help a property owner or manager properly capital plan for remedial projects, rather than be surprised.

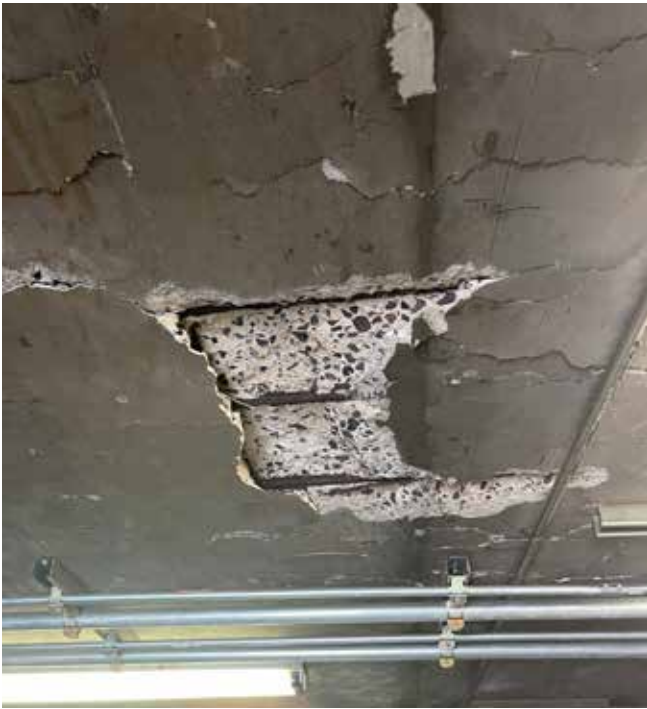
Elevator machine room ceiling damage

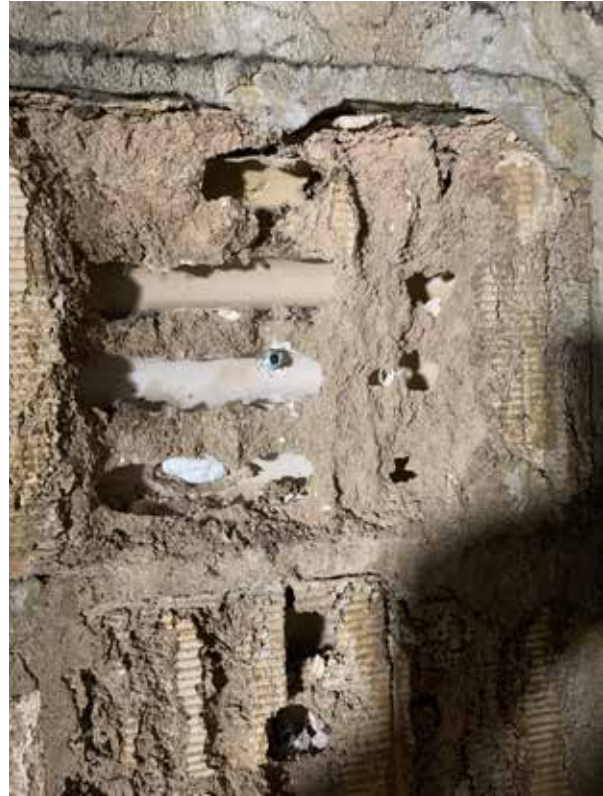
Damage caused by improper anchor installation

holding wires, cables or bus bars^[1] – in the hallways of a 30-story building. The anchors used caused penetration into the elevator shaft. Debris was sent down into the shaft and onto the elevator cartop. This situation became a “reactive” one, and also warranted further investigation into the shaftway materials. This, in turn, caused immediate, unexpected elevator downtime.

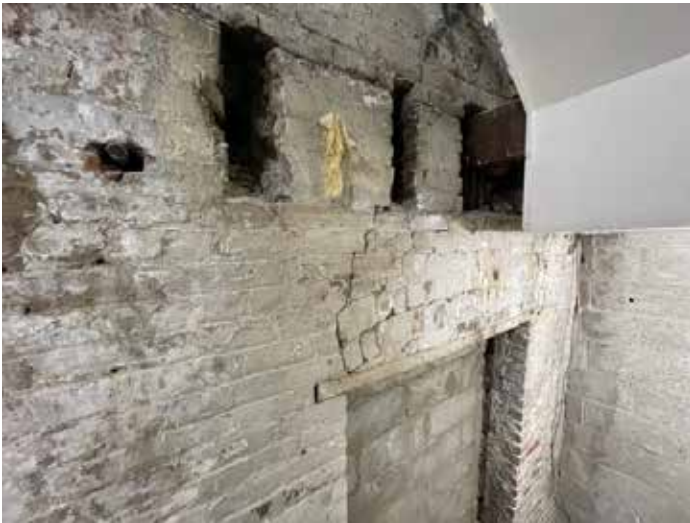
Water-damaged shaftway before repair

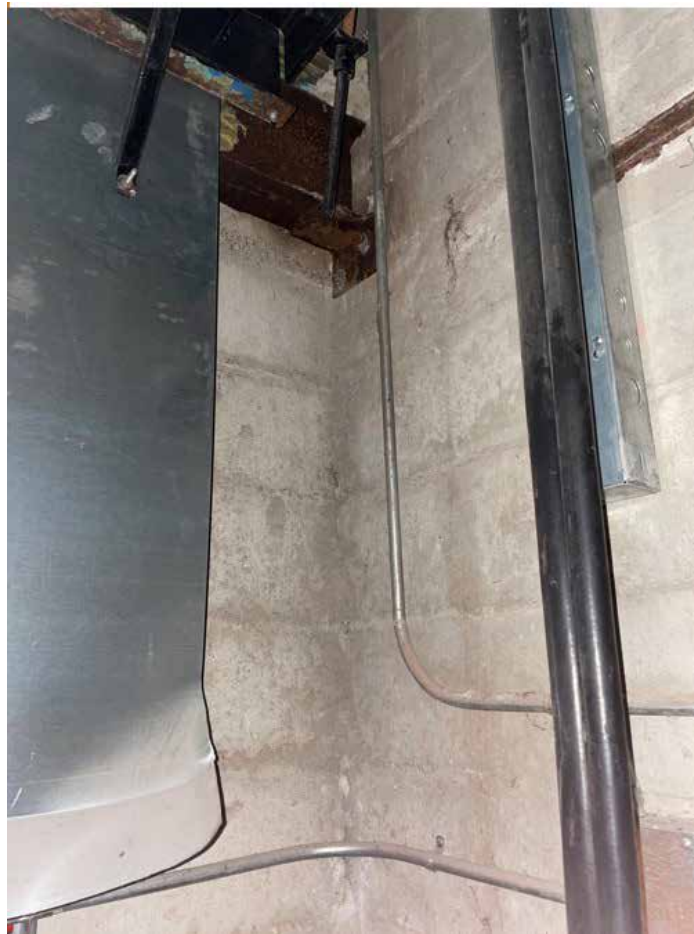
Water-damaged shaftway after repair

PM: For FRCM, a correctly protected elevator roof is used as the access platform. The remaining shaft and elevator equipment is properly protected, and RUREGOLD is applied over deteriorated surfaces. By providing “structural stucco” to deteriorated surfaces, the application facilitates fast project completion and optimum repair results. One of our recently completed projects was an elevator shaft in a historic, 140-year-old building in downtown NYC. The scope of work included application of FRCM over the existing, deteriorated CMU walls to achieve structural stability within the shaft. Our work crews

applied RUREGOLD at specified areas following precise manufacturer instructions and conducted multiple team visits to confirm desired performance. The project was completed on time, within budget and with minimal disruption to building operations.

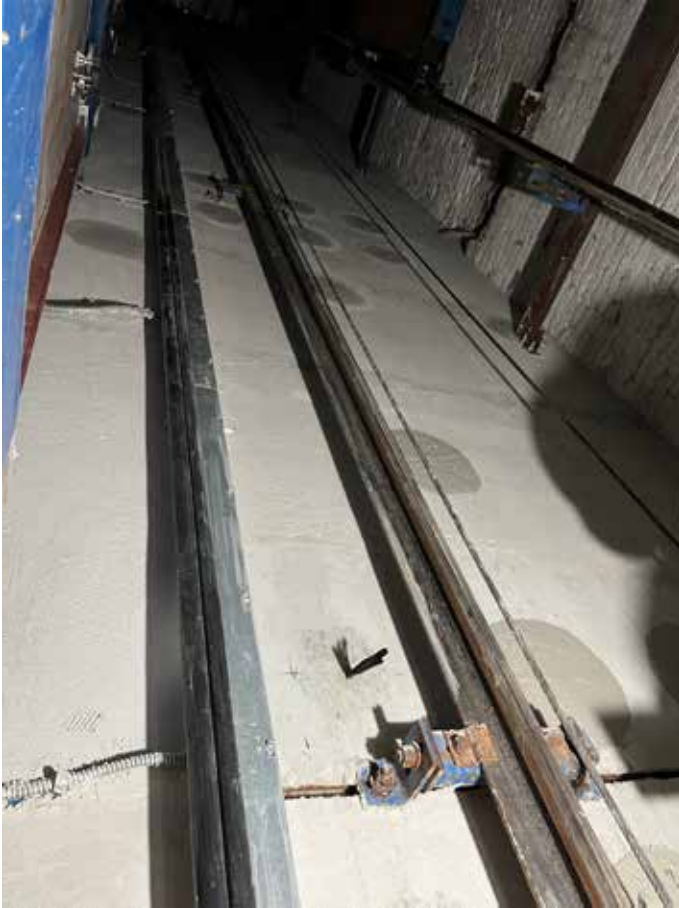
Repaired shaftway
